## Detecting Voids & Delaminations in Carbon Fiber Composite Materials

### Acoustocam™ i600

#### Boeing Finalizes Acoustocam™ NDT Procedure for 787 Dreamliner

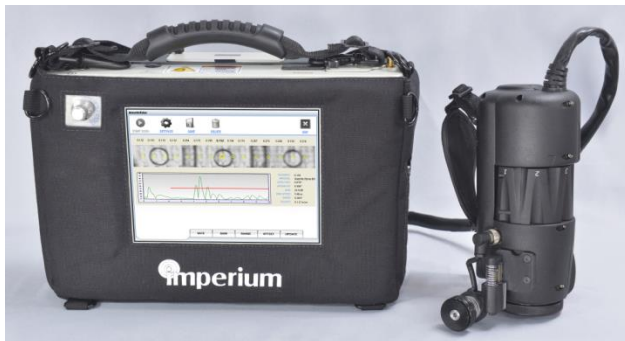
The Acoustocam™ by Imperium solves this challenge by providing instant, high resolution video images of subsurface composite damage without sacrificing quantification data. To use the system, an inspector quickly calibrates the system and scans over a suspected area of damage, while **real time C-scan and A-scan** data is generated. The total time to setup, calibrate, and scan a 12" x 12" area is under 4 minutes. The system requires minimal training. The result is an enhanced user experience, faster turnaround time, and increased aircraft uptime. This efficient use of resources permits more comprehensive data driven inspections to be completed each day. Inspections can be monitored in person or wirelessly in real time for remote collaboration with other personnel.
